Home Inspection Report

45-624 Z Hualukini Place

Kaneohe, HI 96744

Inspected on Thu, Dec 29 2016 at 5:25 PM

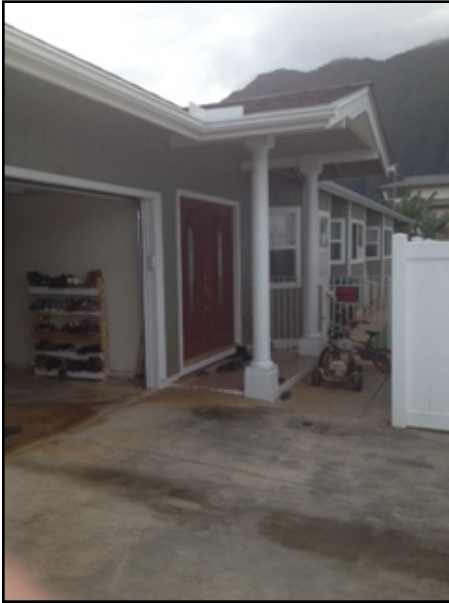
Figure 1-1

Comment 1:
Entry.

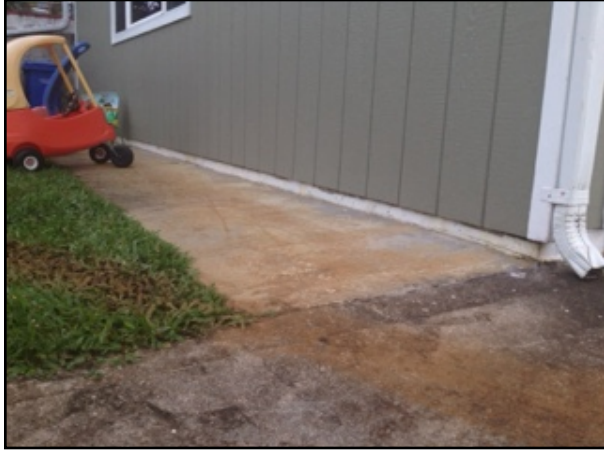
Figure 2-1

Comment 2:
Sloped away from house.

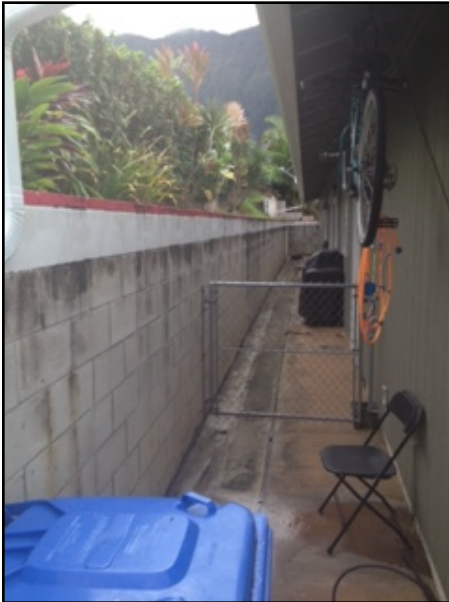
Figure 3-1

Comment 3:
Retaining wall - suggest power washing.

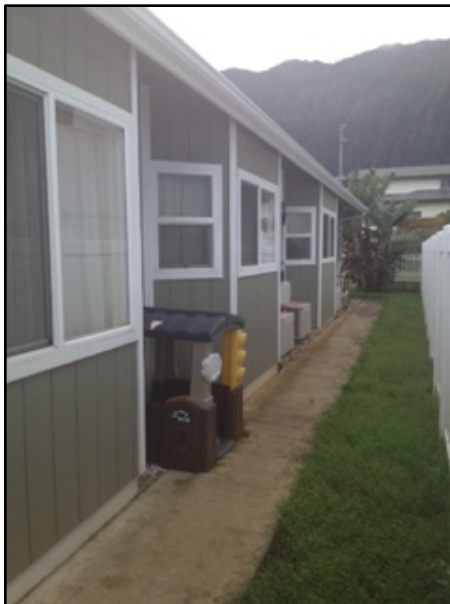
Figure 4-1

Comment 4:
Exterior .

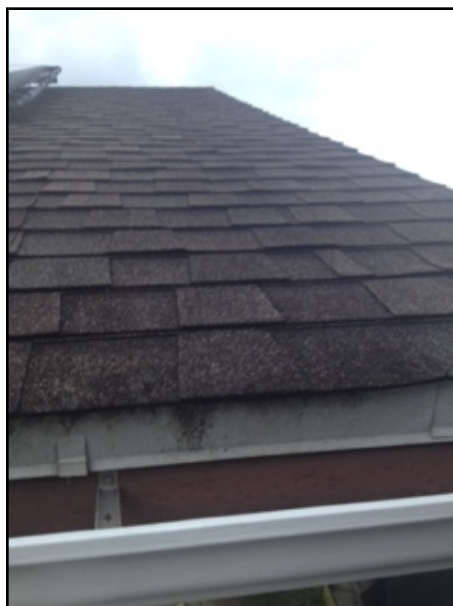
Figure 5-1

Comment 5:
Single layer.

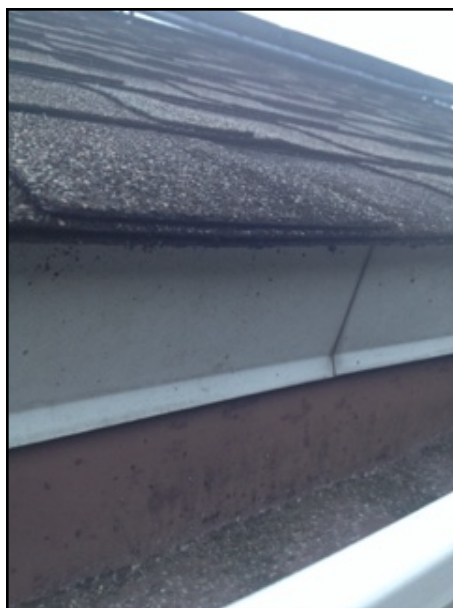
Figure 6-1

Comment 6:
Flashing.

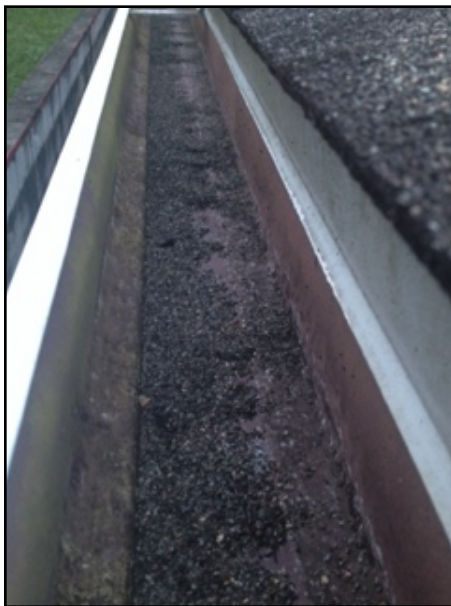
Figure 7-1

Comment 7:
Roofing granulates in gutter.

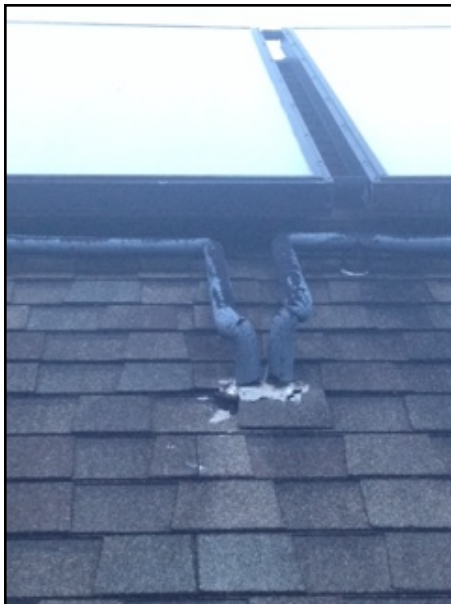
Figure 8-1

Comment 8:
Solar Piping Wrap Shows deficiency & seal -- suggested action have professional solar personal repair.

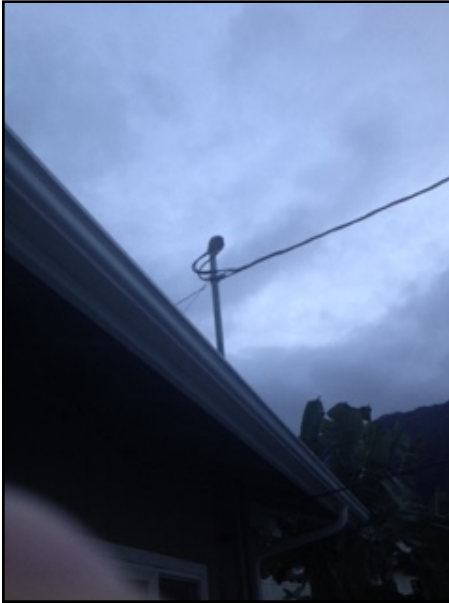
Figure 10-1

Comment 10:
Overhead power.

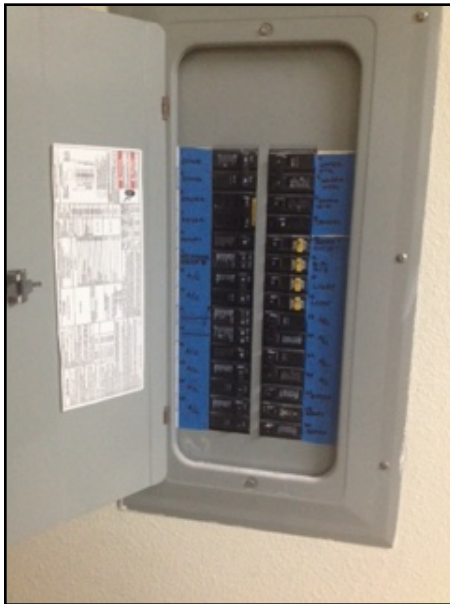
Figure 11-1

Comment 11:
Sub panel .well labeled

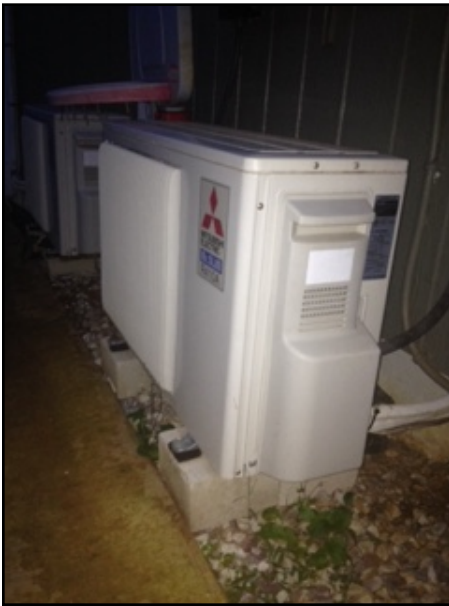
Figure 12-1

AC units in satisfactory conditions with not visual rust .

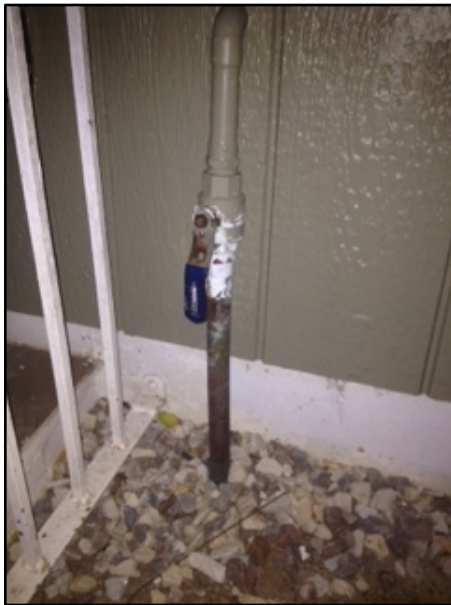
Figure 13-1

Comment 13:
Main shut off.

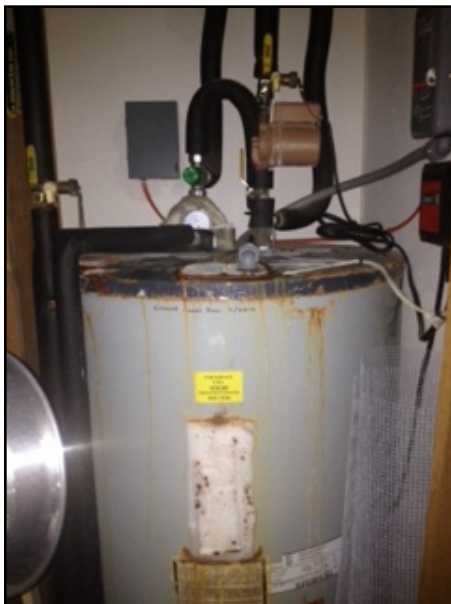
Figure 14-1

Manufacturer:	American water heater
Fuel:	Electric
Capacity:	120 gal solar / electric
Approximate Age:	Approx 20 Years
Temp & Pressure Relief Valve:	Present With Blow Off Leg
	Condition: Marginal

Comment 14:
Water heater.

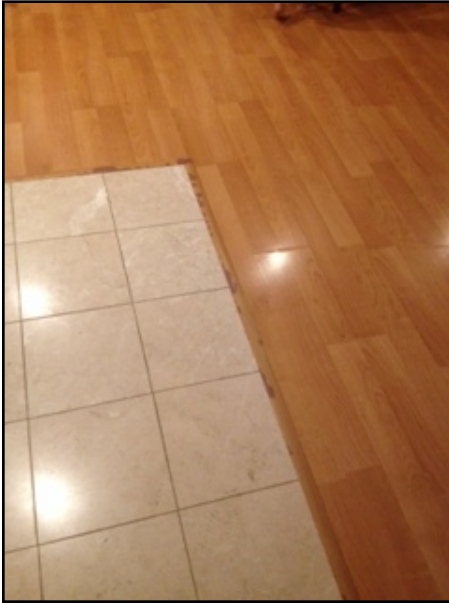
Figure 15-1

Comment 15:
Living room flooring with transition to kitchen .

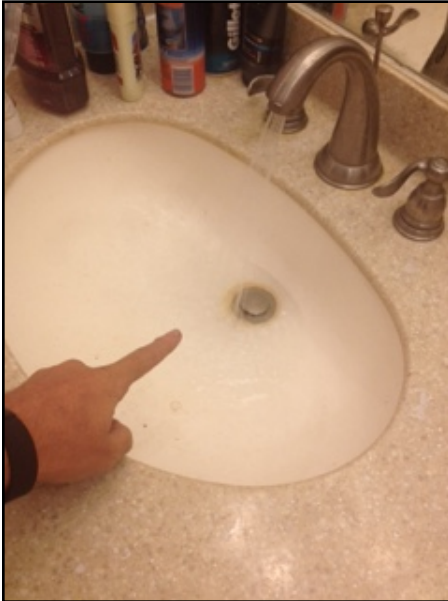
Figure 16-1

Comment 16:
Slow drain - bath 1 in hallway - left sink.

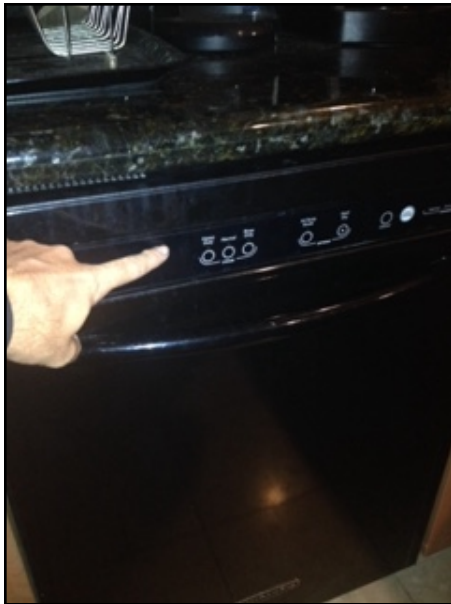
Figure 20-1

Refrigerator:	Kenmore Condition: Satisfactory
Dishwasher:	Kitchen Aid, Display function non operational Condition: Repair or Replace
Disposal:	Badger Condition: Satisfactory
Washer:	Kenmore Condition: Satisfactory
Dryer:	Kenmore Condition: Satisfactory

Comment 20:
Non operational display unit.

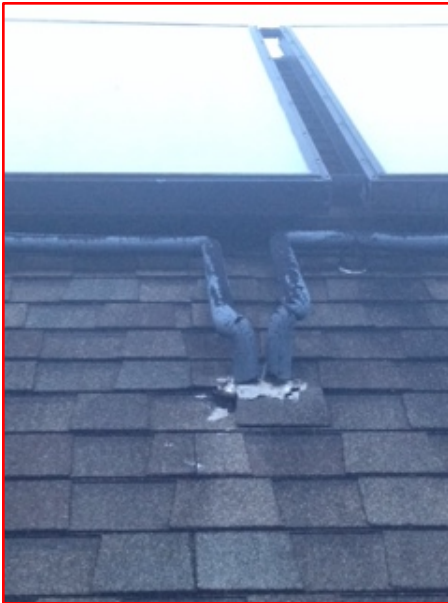
Figure 8-1

1) Solar Piping Wrap Shows deficiency & seal -- suggested action have professional solar personal repair.

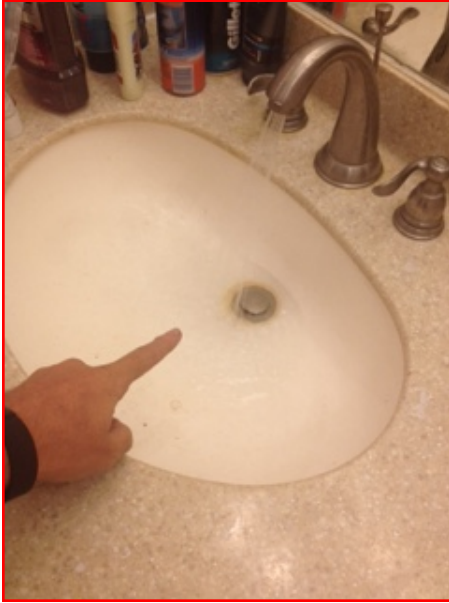
Figure 16-1

2) Slow drain - bath 1 in hallway - left sink.

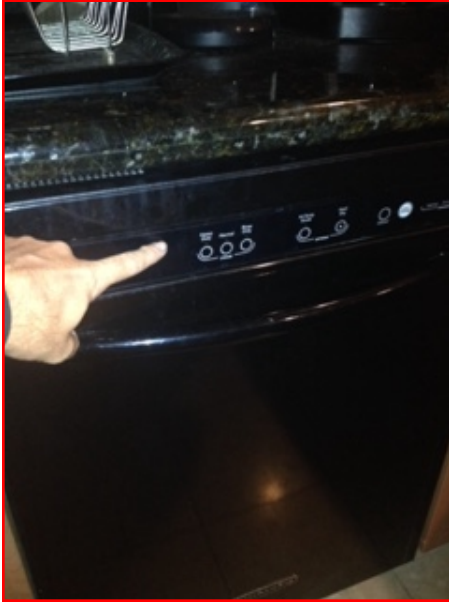
Figure 20-1

5) Non operational display unit.
