Signature Inspections Hawaii

Home Inspection Report

46-259 Kahuhipa St

Inspected on Fri, Dec 30 2016 at 11:32 AM

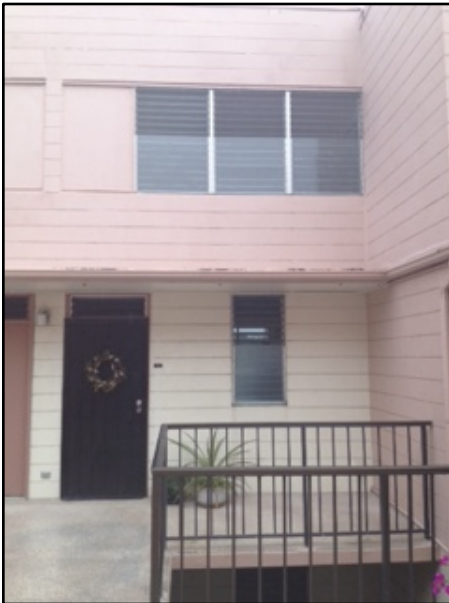
Figure 1-1

**Comment 1:**
General Photo - Exterior / Main Entry Door with viewpoint of 1st & 2nd floors.

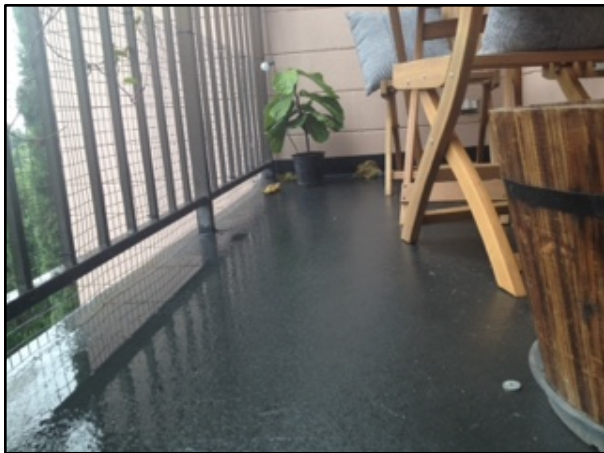
Figure 2-1

Site Grading - Away from residence - Water moves away from structure towards exterior in all areas.

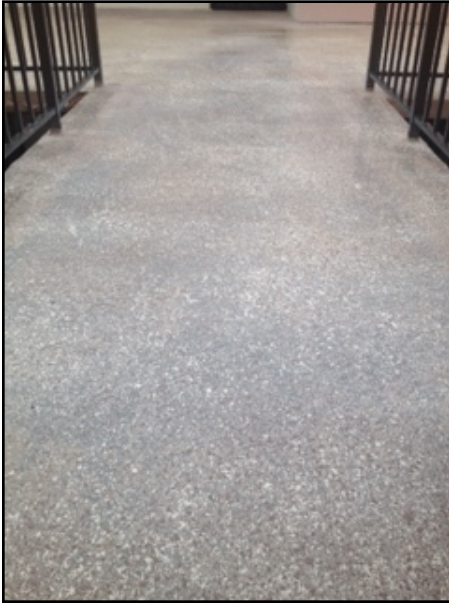
Figure 3-1

Comment 3:
Entry walk way.

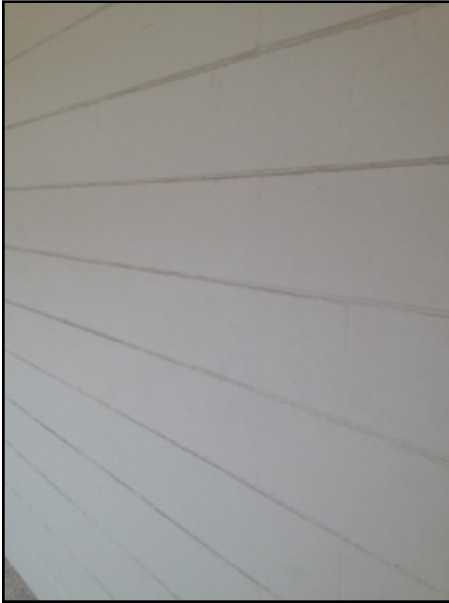
Figure 4-1

Comment 4:
Exterior 1st floor.

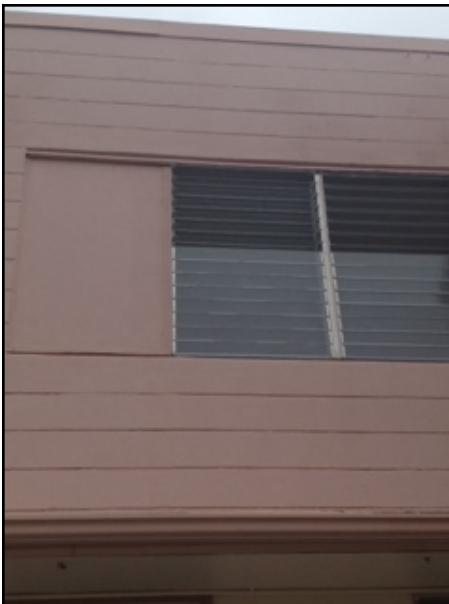
Figure 5-1

Comment 5:
Exterior - 2nd floor .

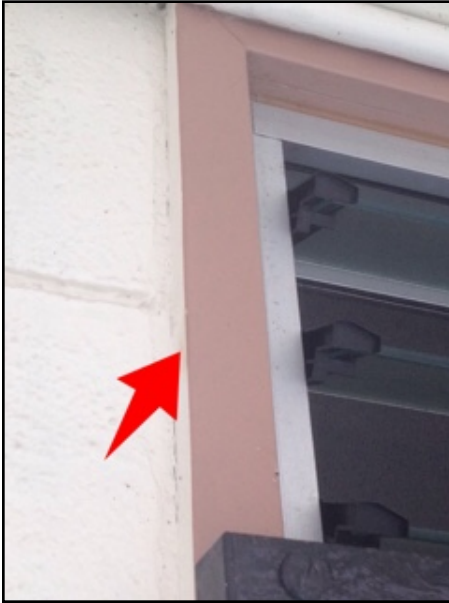
Figure 6-1

Comment 6:
Exterior Trim - Satisfactory Condition .

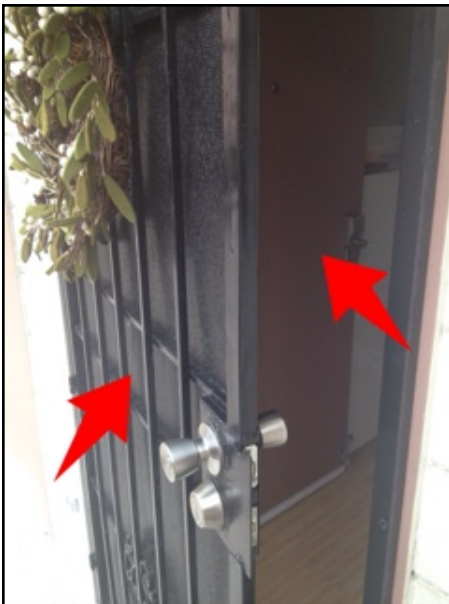
Figure 7-1

Comment 7:
Security Door + Entry Door .

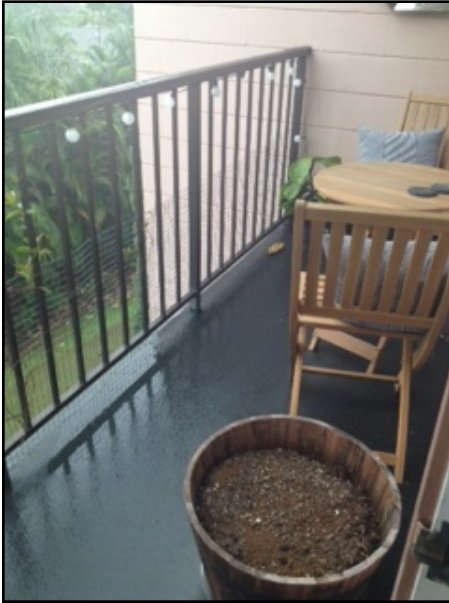
Figure 8-1

Comment 8:
Exterior Balcony on 1st level .

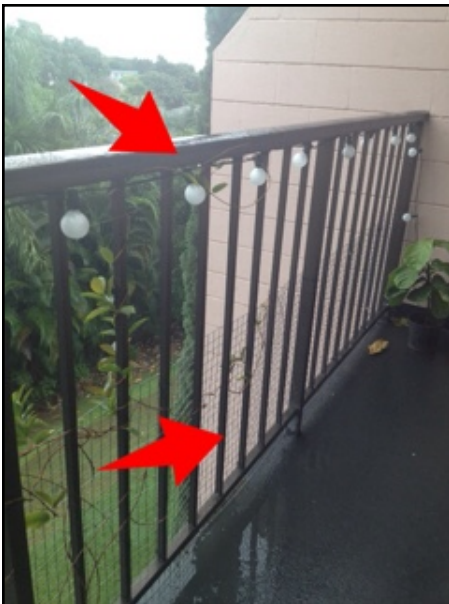
Figure 9-1

Comment 9:
Balcony Railing. Condition satisfactory Meets code on spindles / gaps

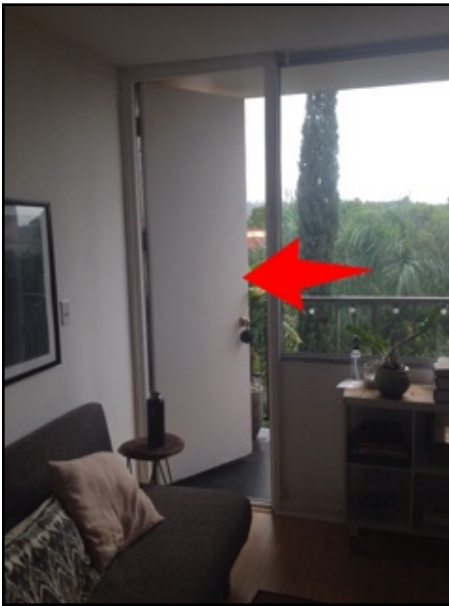
Figure 10-1

Comment 10:
Balcony Door - Solid Core / Oversized in height - Satisfactory Condition .

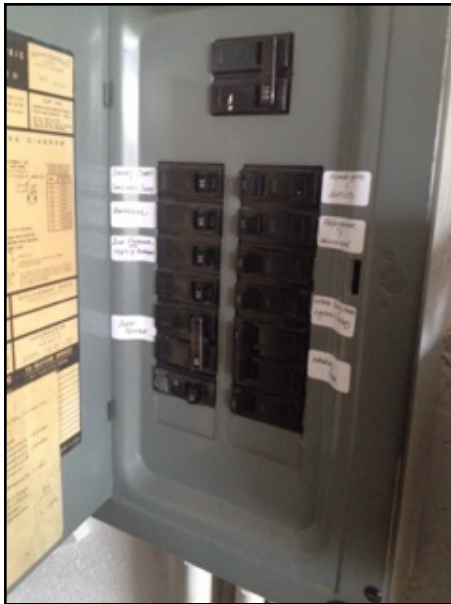
Figure 12-1

Comment 12:
Interior Electrical Panel clear labeling.

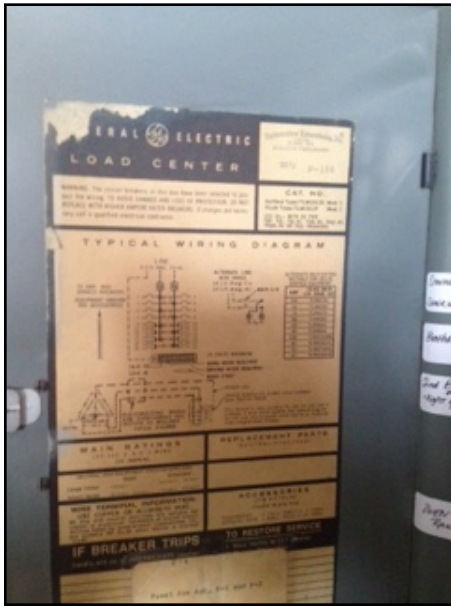
Figure 13-1

Comment 13:
Electrical panel - General Electric .

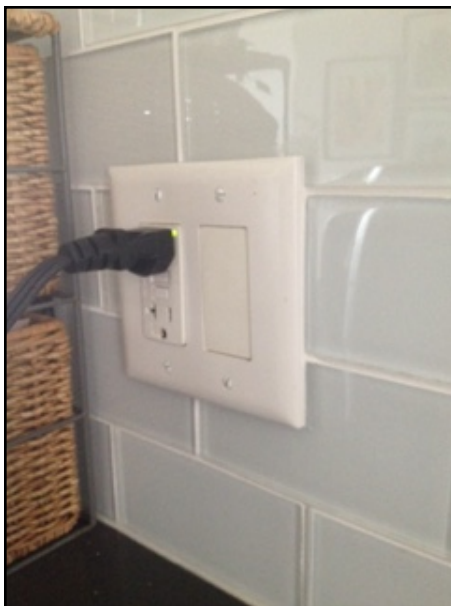
Figure 14-1

Comment 14:
GFCI.

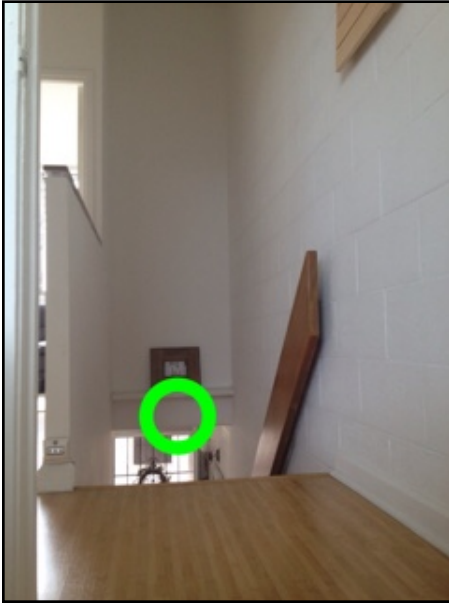
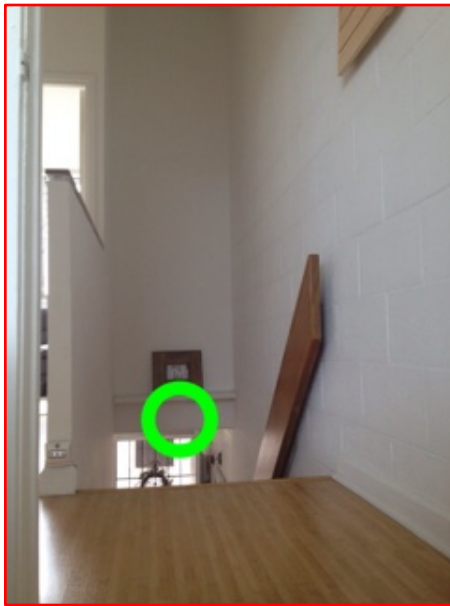
Figure 15-1

Comment 15:
No Smoke Detector - Possible / Suggested Location 3.

1) No Smoke Detector - Possible / Suggested Location 3.

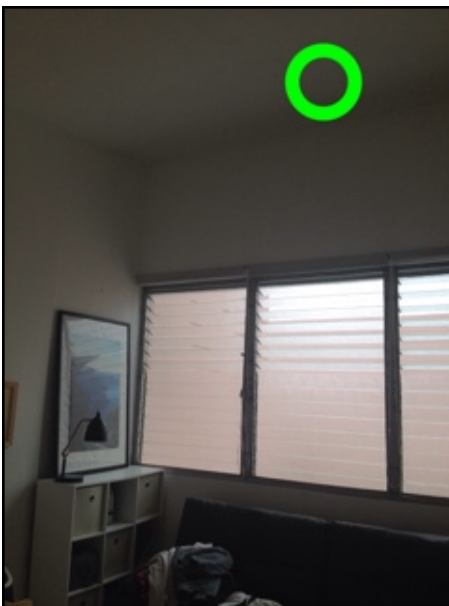
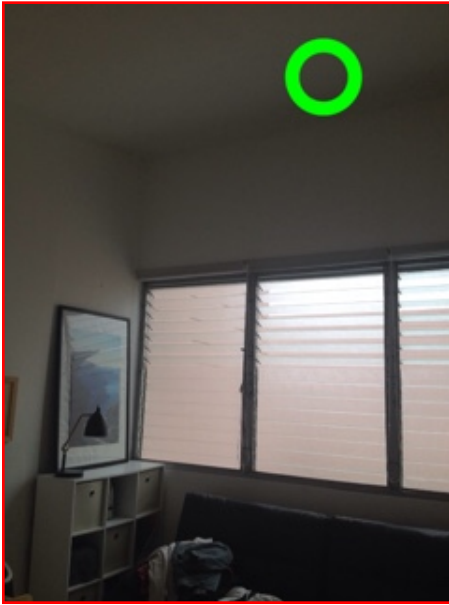
Figure 16-1

Comment 16:
No Smoke Detector - Possible / Suggested Location 2.

2) No Smoke Detector - Possible / Suggested Location 2.

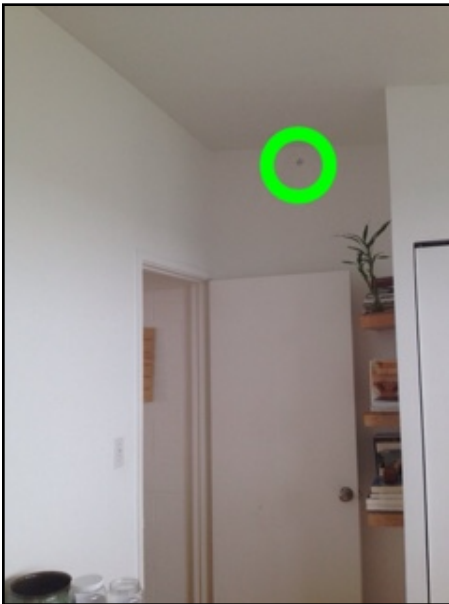
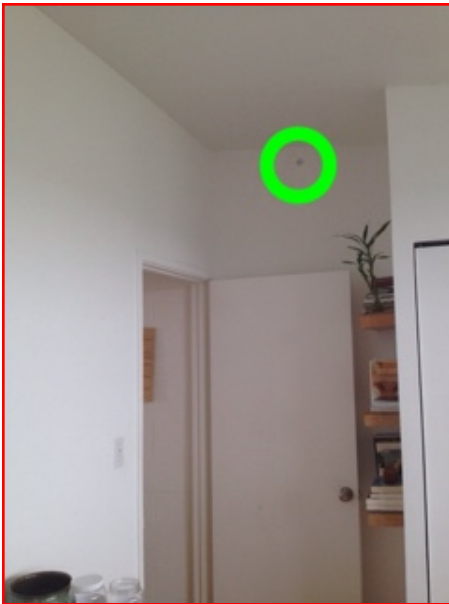
Figure 17-1

Comment 17:
No Smoke Detector - Possible / Suggested Location 1.

3) No Smoke Detector - Possible / Suggested Location 1.

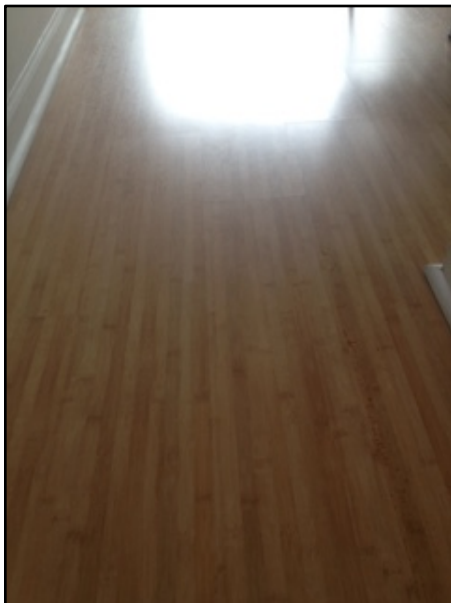
Figure 19-1

Flooring - satisfactory .

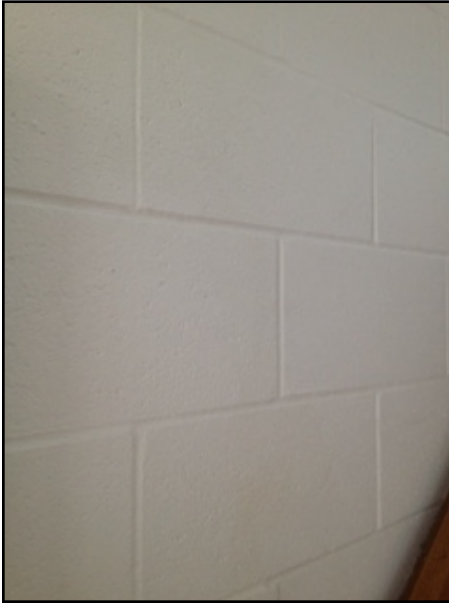
Figure 20-1

Wall - concrete (no cracks) condition satisfactory .

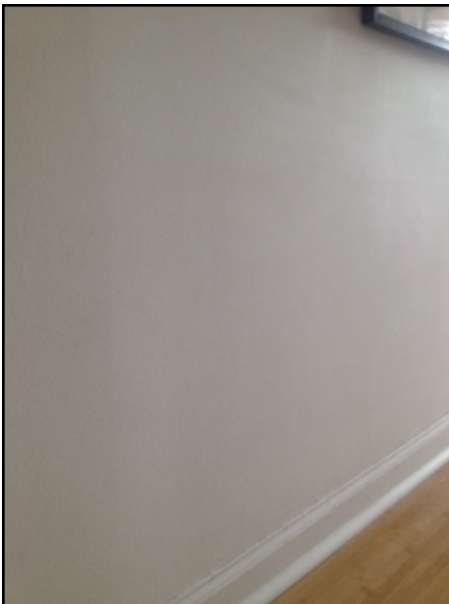
Figure 21-1

Wall - Dry wall w/ paint - minor patching repairs visible - condition: satisfactory .

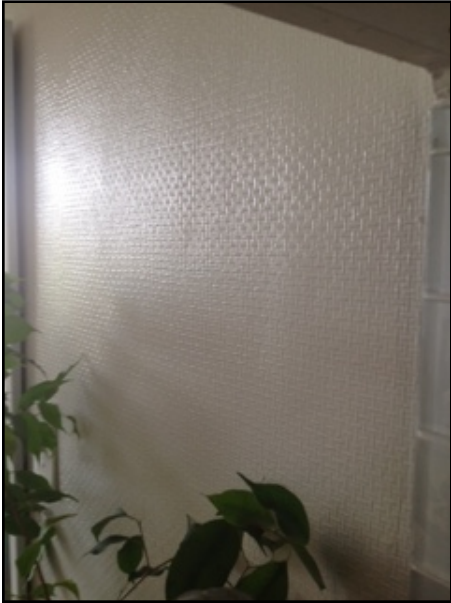
Figure 22-1

Comment 22:
Walls with wallpaper cover - no peeling or visible defects - satisfactory .

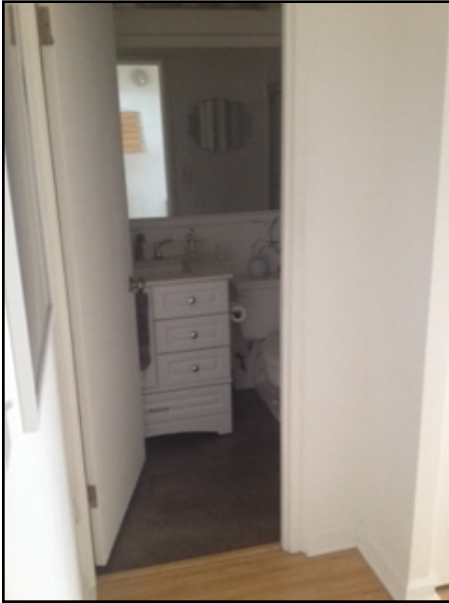
Figure 23-1

Comment 23:
Bathroom: location 2nd floor.

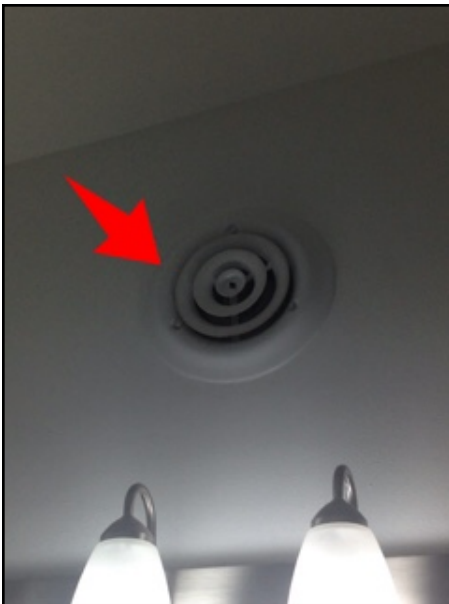
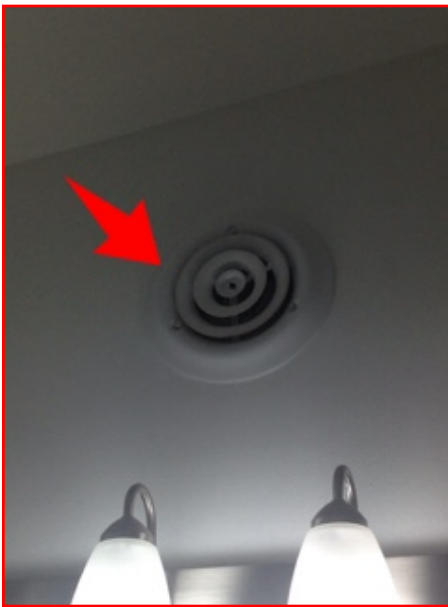
Figure 24-1

Comment 24:
Venting: appears non operational at time of inspection suggest professional inspection (zero air movement at time of inspection) .

5) Venting: appears non operational at time of inspection suggest professional inspection (zero air movement at time of inspection) .

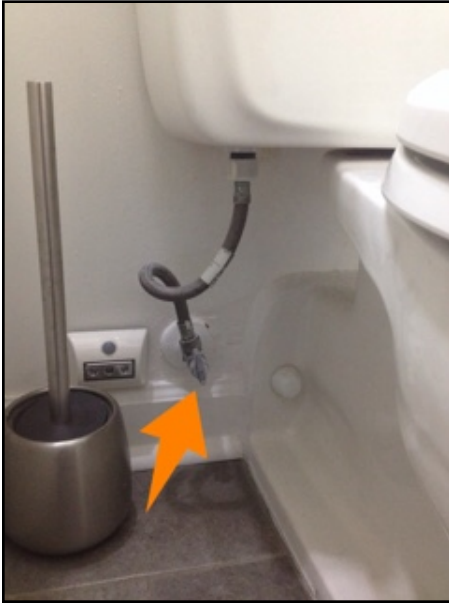
Figure 25-1

Comment 25:
Toilet shut off valve. Minor corrosion and new connection line

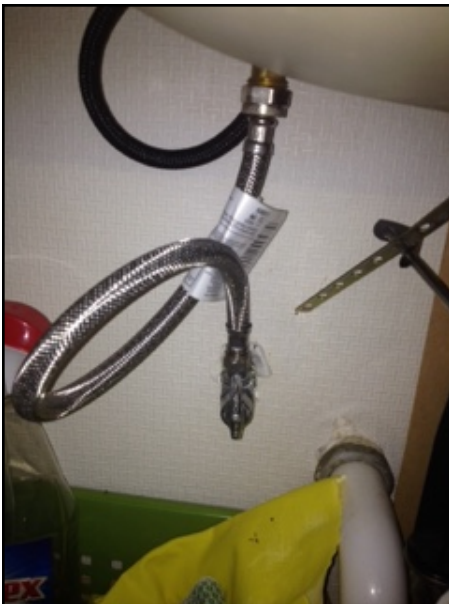
Figure 26-1

Comment 26:
Under sink - new valve & new connector .

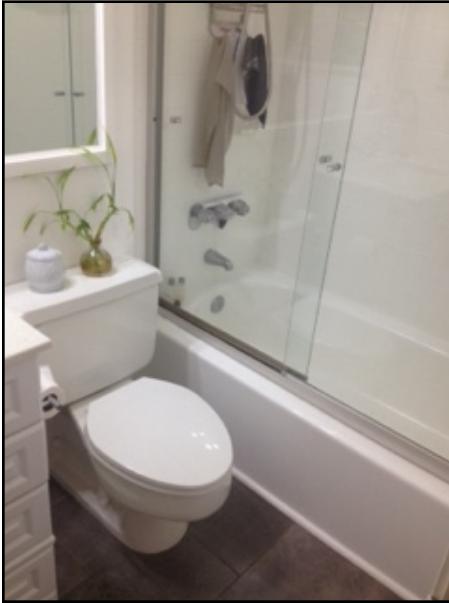
Figure 27-1

Bath, shower, surround, toilet, and caulked / sealed seems.

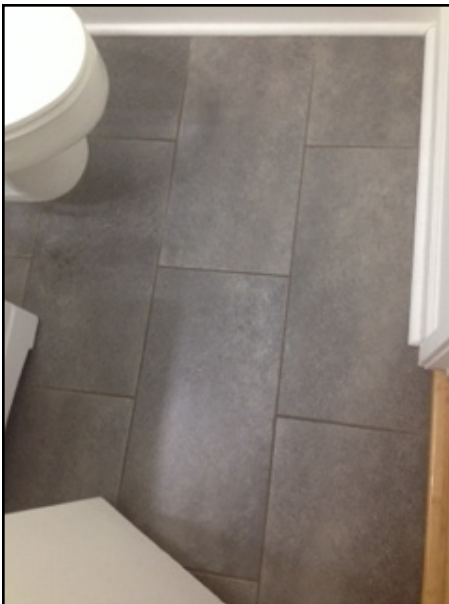
Figure 28-1

Flooring - condition satisfactory .

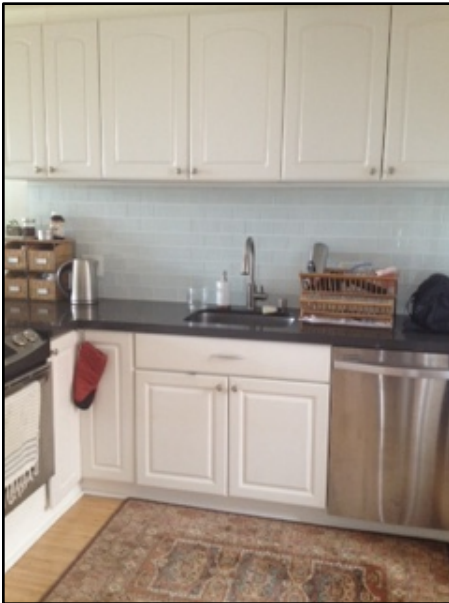
Figure 29-1

Comment 29:
Cabinets- Kitchen .

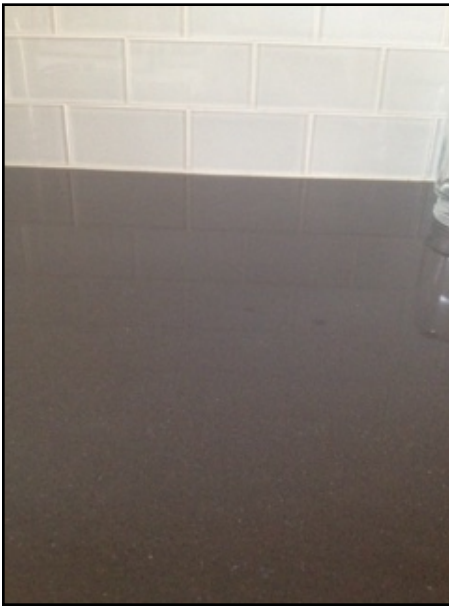
Figure 30-1

Countertops and backsplash - condition: satisfactory .

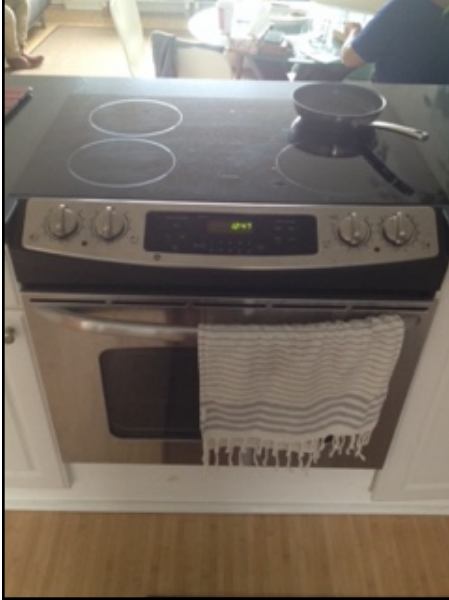
Figure 31-1

**Comment 31:**
GE : Cooktop & Oven - texted: all heating elements satisfactory at time of inspection.

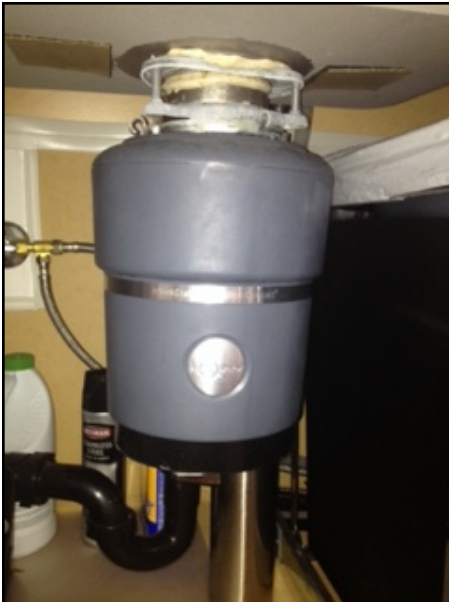
Figure 32-1

**Comment 32:**
Disposal - satisfactory .

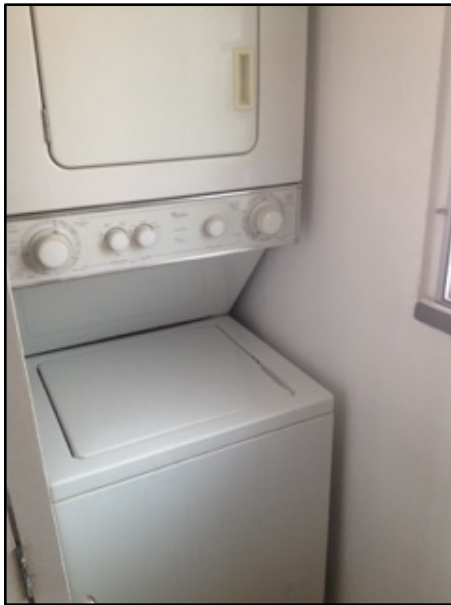
Figure 33-1

Comment 33:
Clothes - washer / Dryer - laundry .

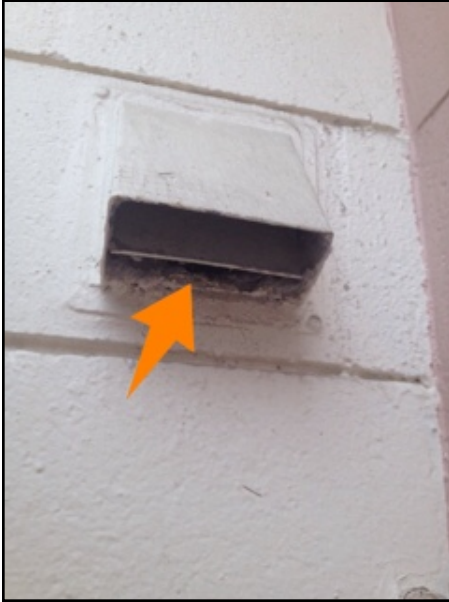
Figure 34-1

Exterior dryer venting. FYI: Dryer venting cleaning or repairs suggested as venting flap will not shut - possible access for rodents / insects

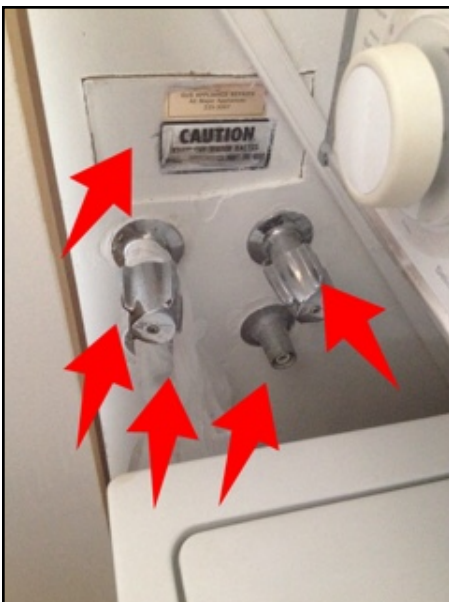
Figure 35-1

FYI: Did not test / operate - contact professional plumber to confirm is operational or non operational .

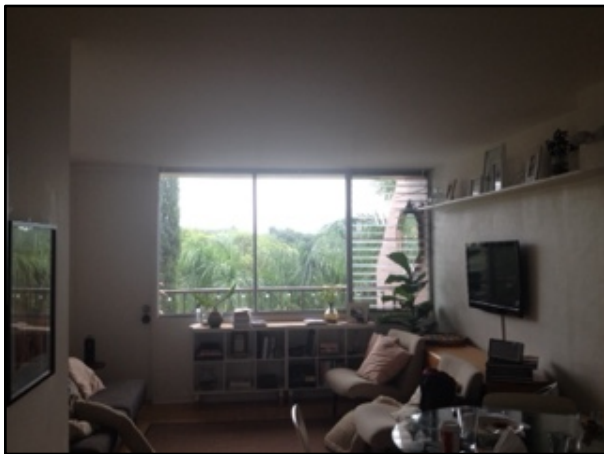
Figure 36-1

Comment 36:
Window - fixed, slider, jealousyly .

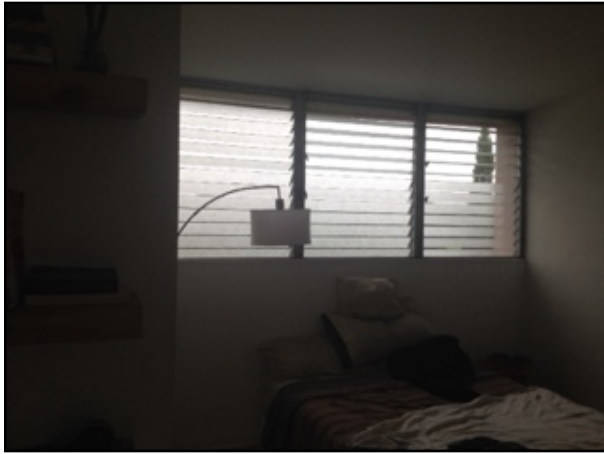
Figure 37-1

Comment 37:
Bedroom windows - jealously .

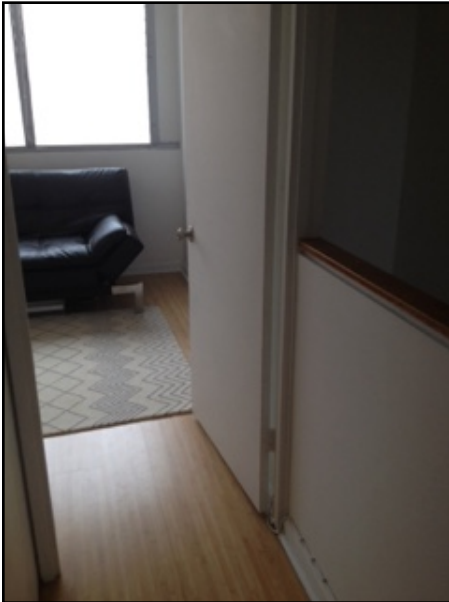
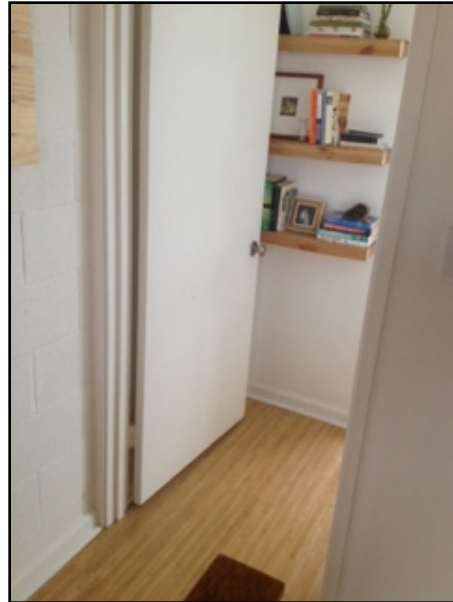
Comment 38:
Interior bedroom doors.

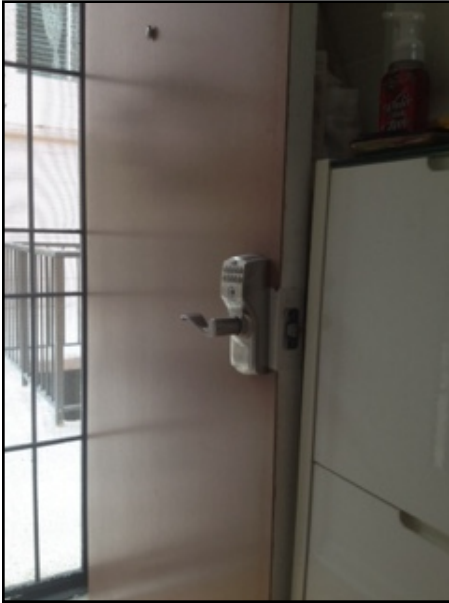
Figure 39-1

Entry door with combo & key entry system.
